# Sediment PCB Cleanup Remedy Effectiveness: Case Study Synthesis

Presented by: Clay Patmont, Anchor QEA Collaborators: Paul Doody and Betsy Henry, Anchor QEA Suzanne Replinger, Windward

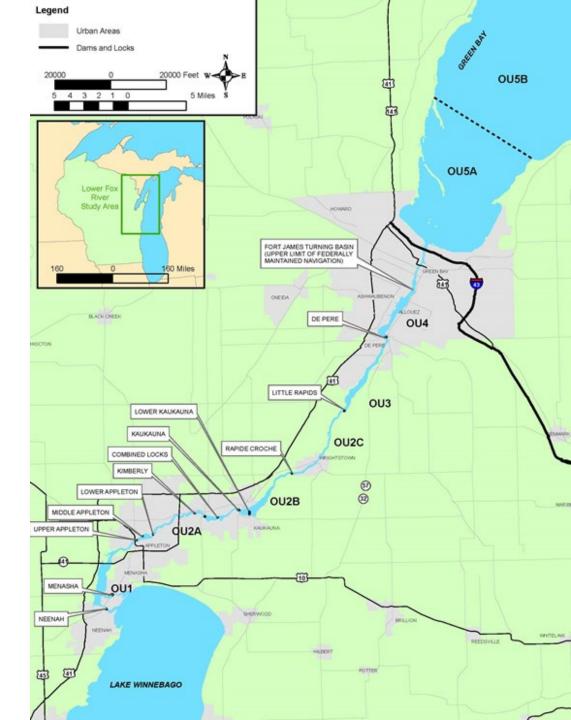
# Fox River, Wisconsin

- PCBs from carbonless copy paper discharged from 1954 to 1971
- Operable Unit (OU) 1: 2004 to 2009
  - Dredge (370,000 cy), cap, and cover
- OU 2: natural recovery subareas
- OU 3: 2009 to 2011
  - Dredge (240,000 cy), cap, and cover
- OU 4: 2007 to 2020
  - Dredge (5,880,000 cy), cap, and cover

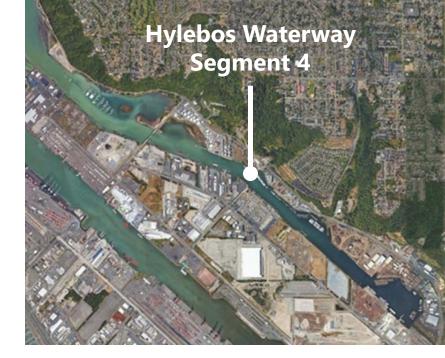
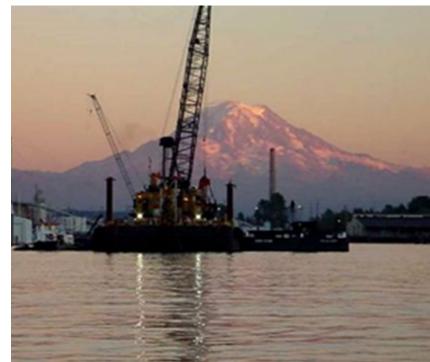
# Hylebos Waterway, Washington

- Part of Commencement Bay Site
- Numerous historical PCB sources
  - Extensive wastewater/stormwater controls and upland/shoreline cleanup actions: 1985 to 1999
  - Source control verified in 2001
- Sediment remediation: 2001 to 2006
  - 24 acres dredged (1,500,000 cy)
  - 8 acres monitored natural recovery
  - 3 acres capped

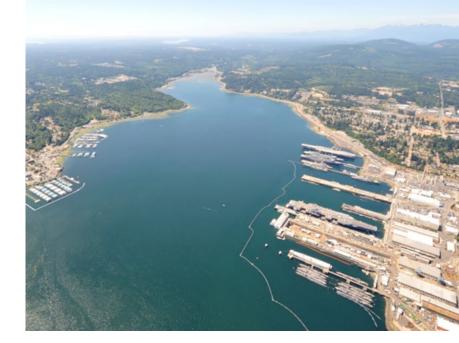
# Sinclair Inlet, Washington

- Numerous historical shipyard PCB sources
  - Continuous process improvements and upland cleanup actions beginning in 1992
- Navigation dredging in 1994/1995
- Navigation/Superfund actions in 2000/2001
  - 32 acres dredged (225,000 cy)
  - 13 acres capped or sand covered
- Shipyard infrastructure projects in 2011
- Fish tissue sampling: 1991 to 2017
