Dredging Contaminated Sediments Mixed with Large Building Demolition Debris, Artifacts, and Munitions

Presented by: Kendra Skellenger, PE, Anchor QEA
Collaborators: Todd Thornburg, PhD, RG, Anchor QEA;
Bob Wyatt, RG, NW Natural; and Mike Crystal,
Sevenson Environmental Services

Former Portland Gas Manufacturing (PGM) Site Location and History

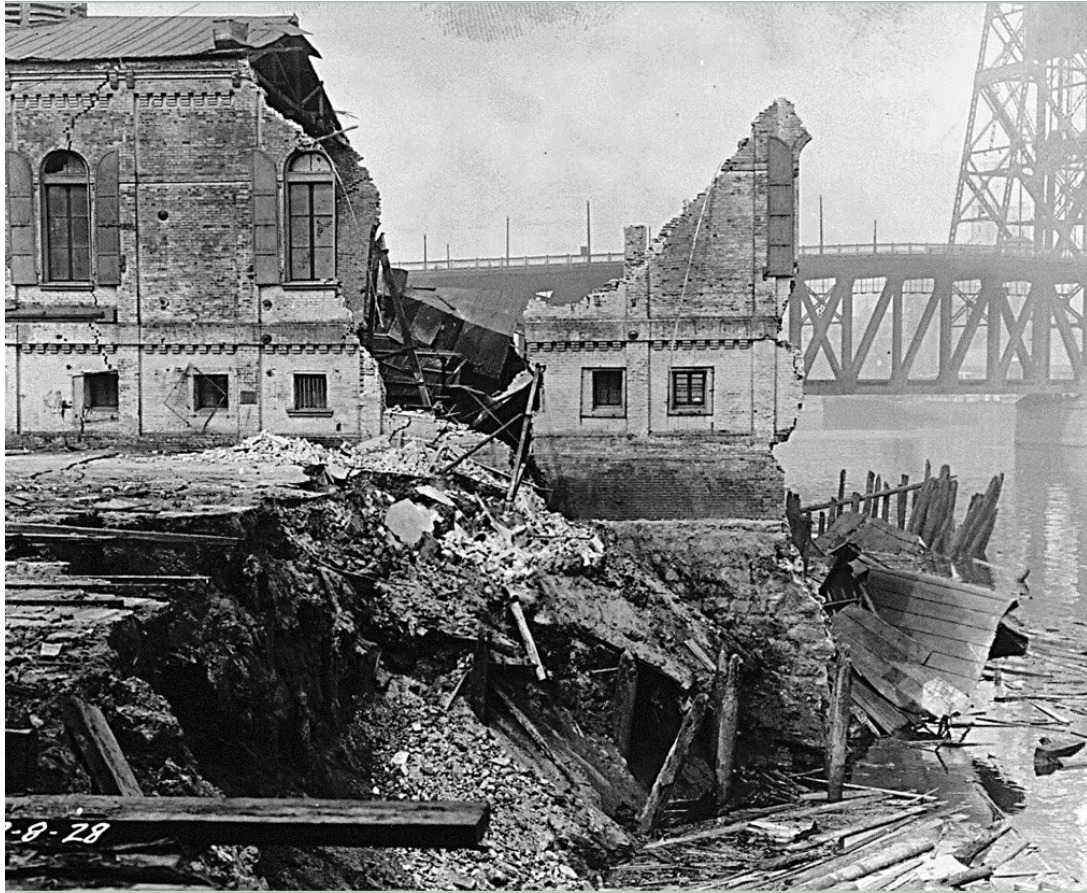
Diver Photos of Offshore Building Debris

Former PGM plant structure

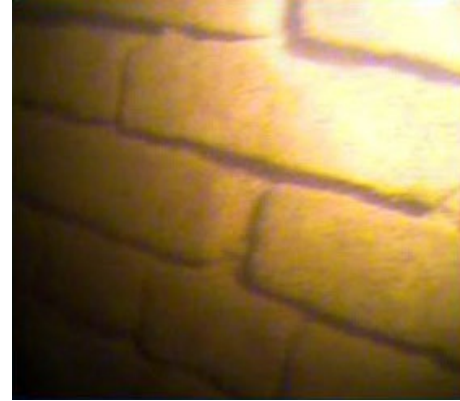
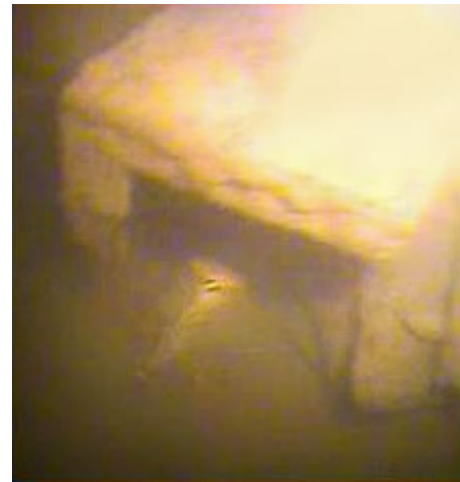
Brick wall, angle iron, and arch window

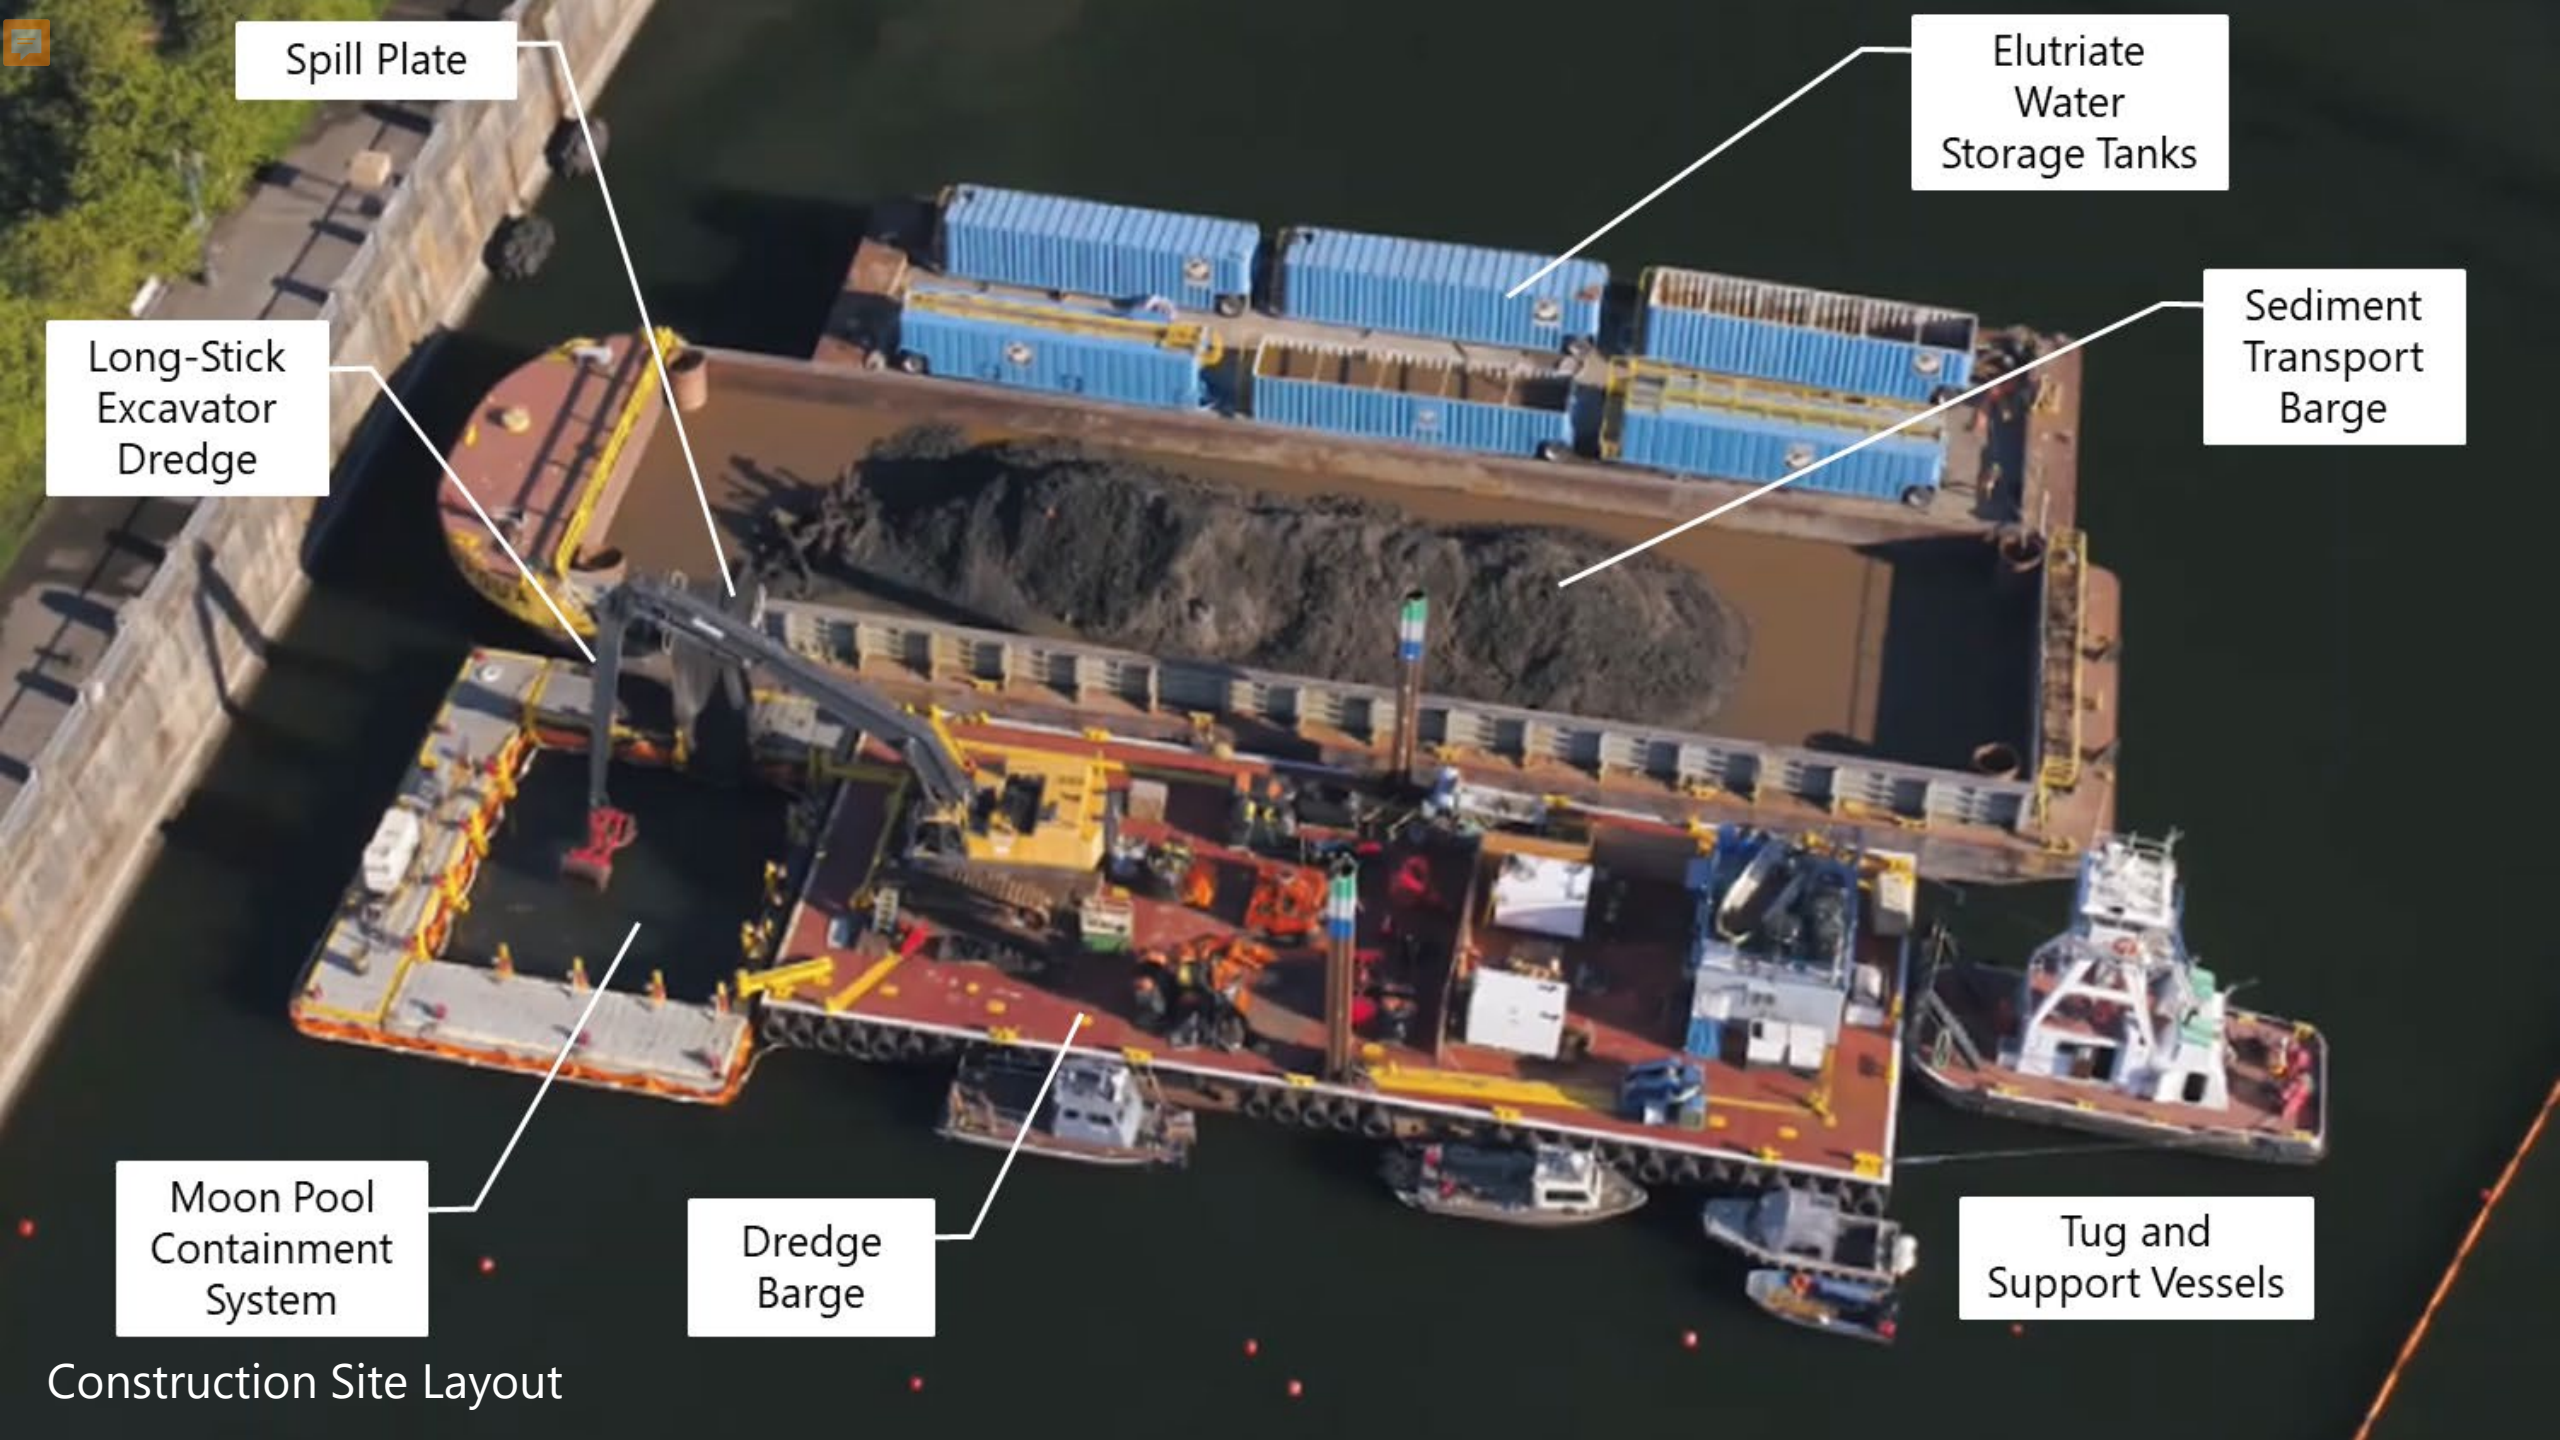
Construction Site Layout

Spill Plate

Elutriate
Water
Storage Tanks

Long-Stick
Excavator
Dredge

Sediment
Transport
Barge

Moon Pool
Containment
System

Dredge
Barge

Tug and
Support Vessels

- Initial surface debris removal activities began July 13
- Additional subsurface debris continued to be encountered and removed along with contaminated sediment through the end of dredging
- Debris removal was also required to prepare substrates for cap and cover placement
- In addition to historical demolition debris, other items encountered included modern trash, potential cultural objects, logs and pilings, and World War II munitions

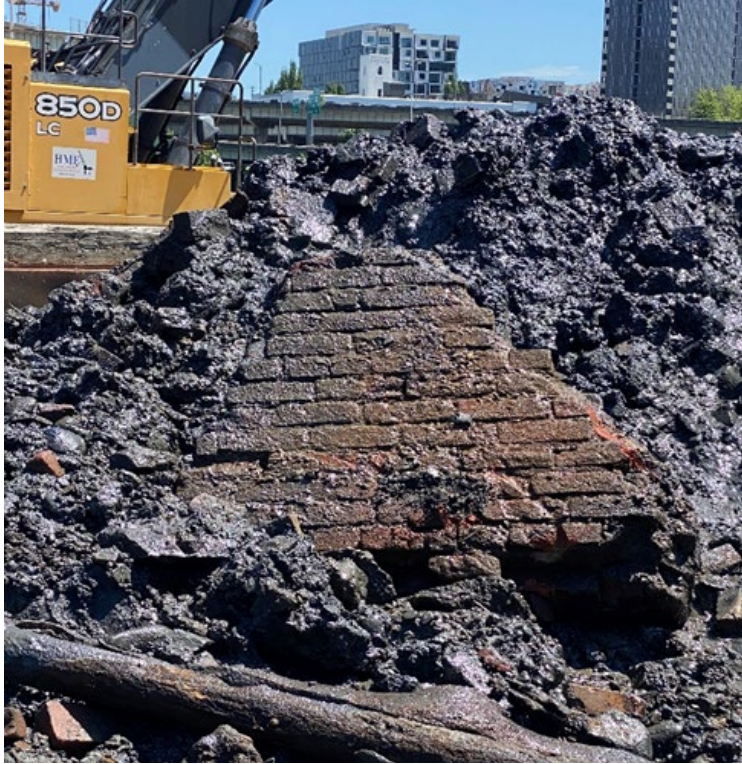
Brick wall segment

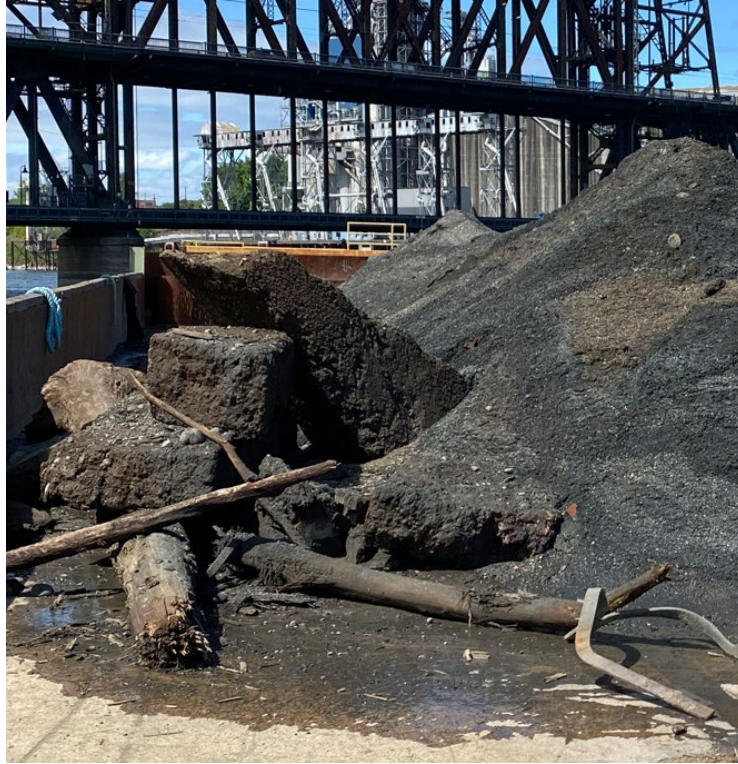
Concrete blocks

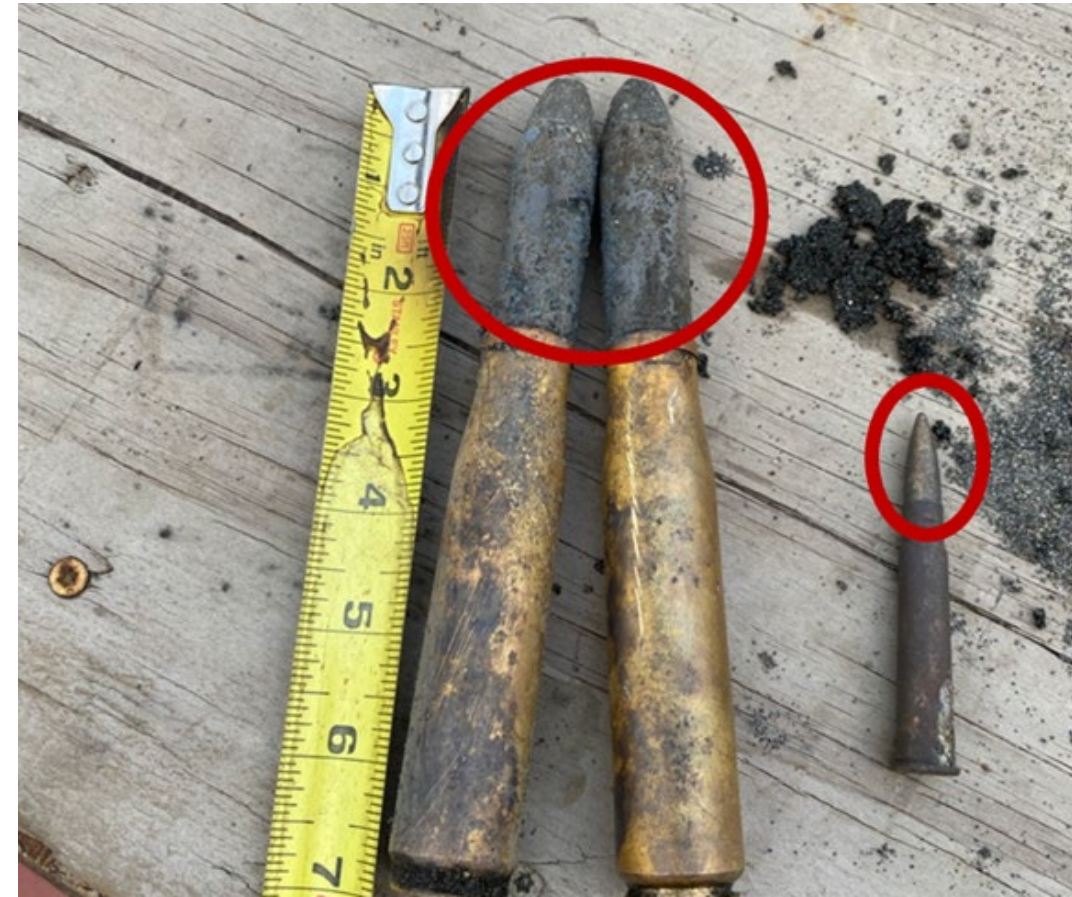
20-mm rounds and rifle bullet

- World War II-era Munitions and Explosives of Concern (MEC) discovered July 23, 2020
 - Two 20-mm rounds and 1 rifle bullet
- Discovered at the base of the spill plate
- Work suspended for 19 days while plans were prepared and safety protections put into place

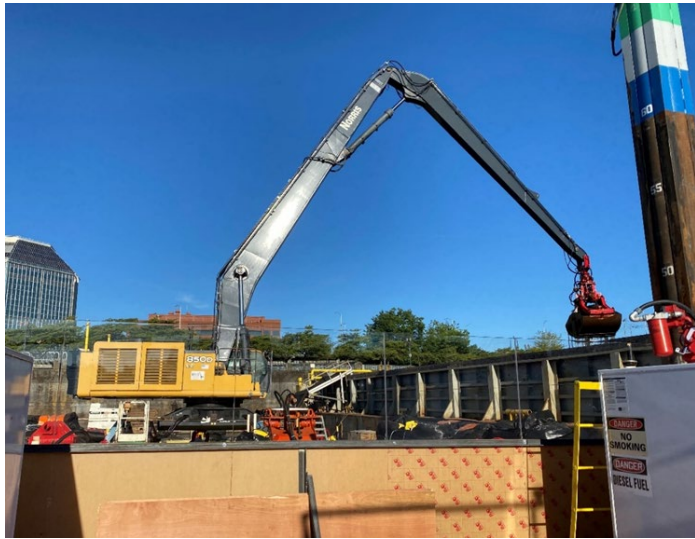
Bulletproof glass barrier

- Engaged munitions expert USA Environmental
- Developed revised work plans for dredging and dredged materials screening for munitions recovery
- Permitted an exclusion zone in Waterfront Park and set up blast shields in work areas
- Munitions sorting operation in Vancouver, Washington

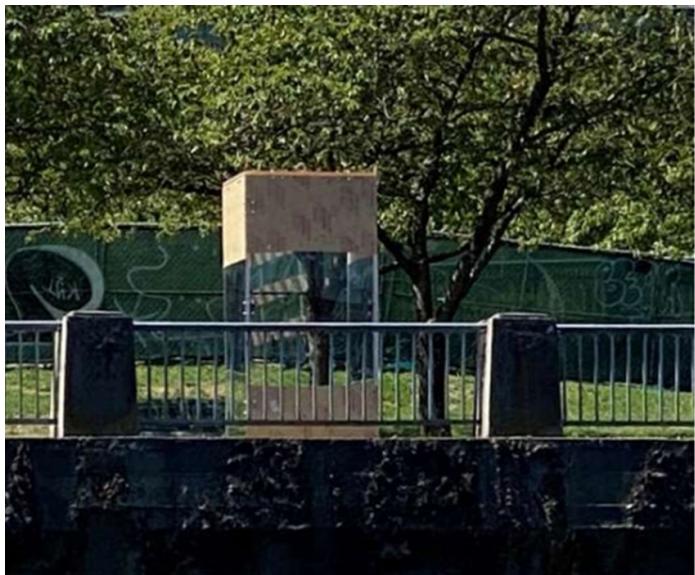
Bulletproof glass agency observation booth

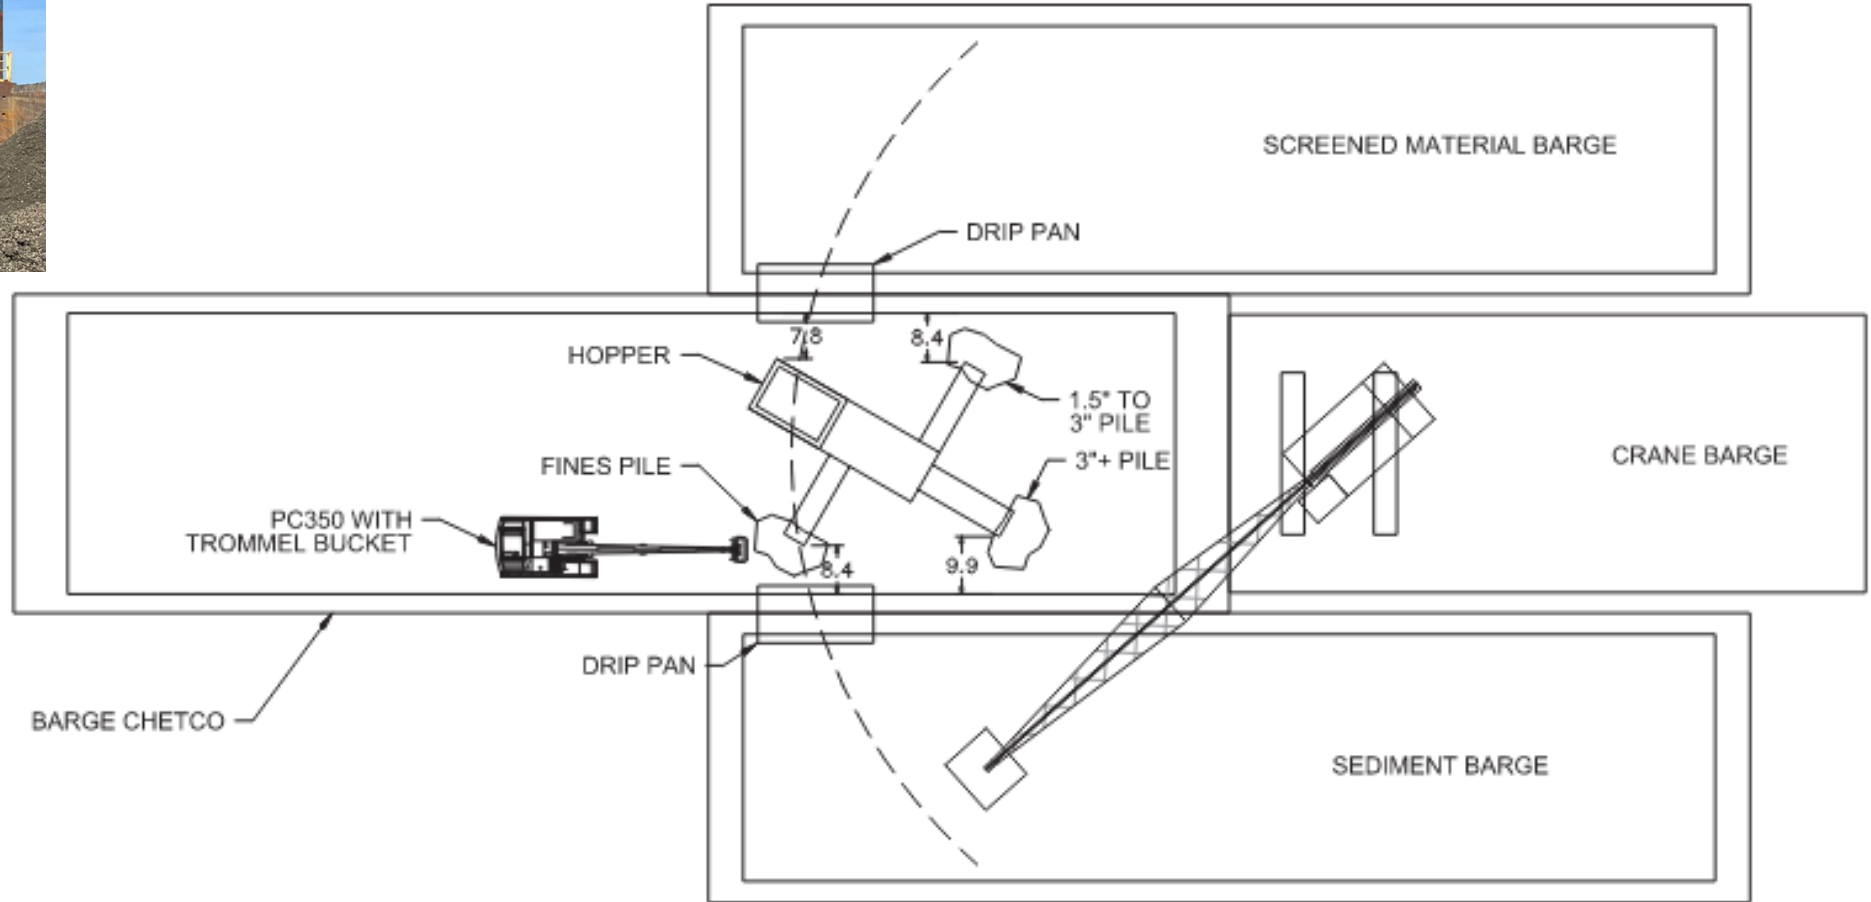
Munitions Screening Process

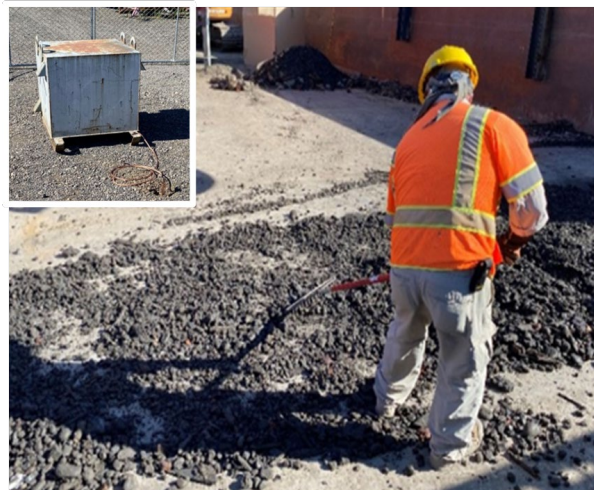
Hand raking by munitions expert

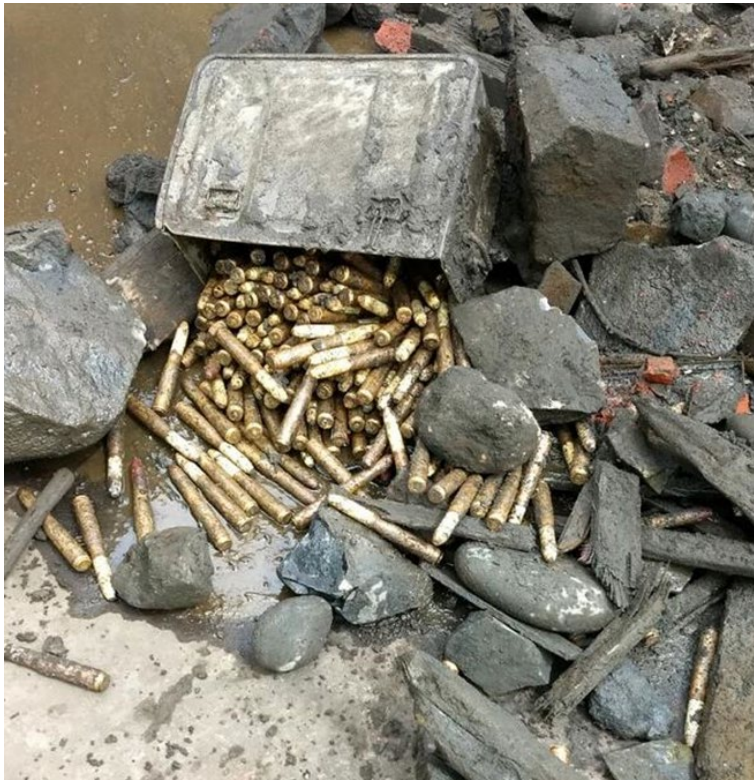
Ammunition box with 36 incendiary and 175 high-explosive 20-mm rounds

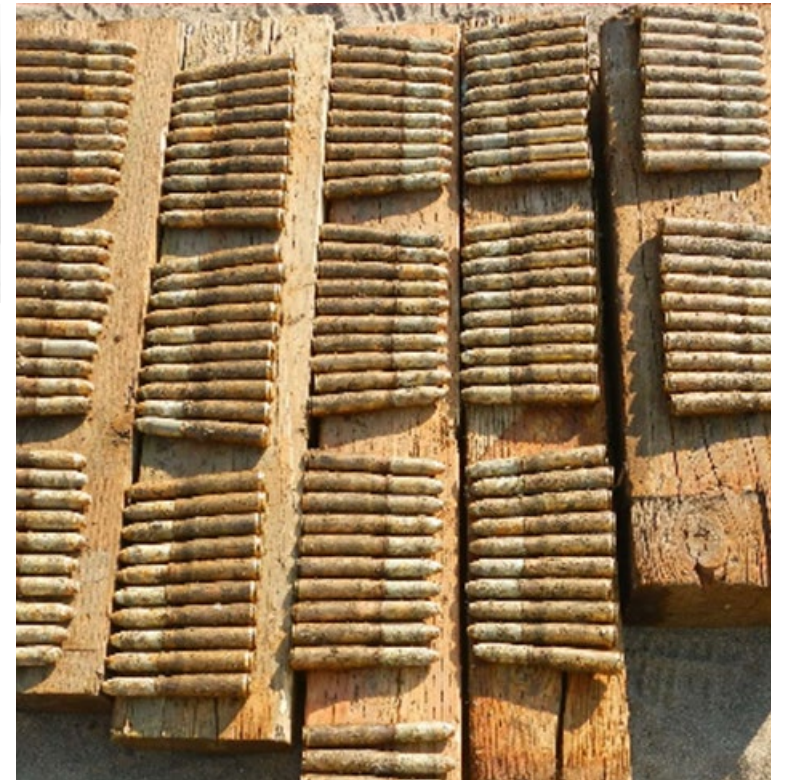
20-mm high-explosive and incendiary rounds
